CITY OF BALTIMORE WET SMOKE AND DYED I	Page 1 of 7				
Sewershed: Low Level Subsewershed: 44	Company: REI/DRAYCO	Date: 09/03/2008 Supervisor: E.R. Crew: 04			
Test Type: Smoke	Ground Condition: Dry: X Damp:_ Wet:_				
Manhole ID: S19I046MH	Test ID: 1029-592	Notifications Made:X Residents, Fire, 311

CITY OF BALTIMORE SMOKE TESTING OBSERVATION SUMMARY LOW LEVELSEWERSHED

BALTIMORE CITY PROJECT 1029 REI/DRAYCO

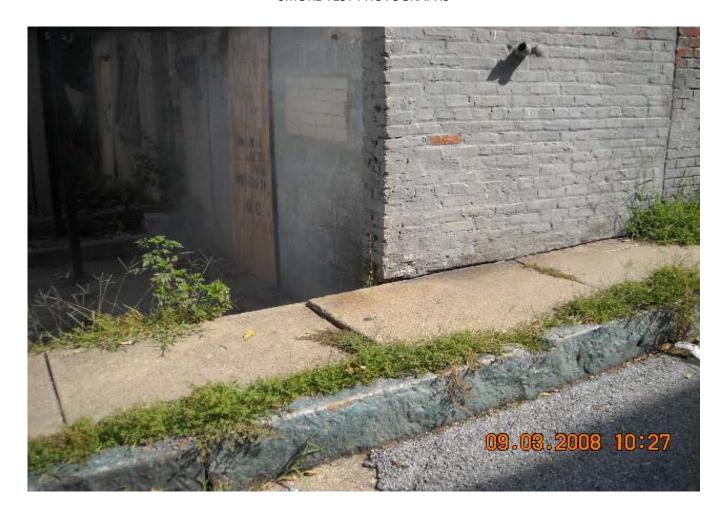
Photograph No: OB01-01 Filename: 1029-592_OB01-01.jpg

Location: 30 S. PULASKI ST.

Source Type: 02 Service Line Sector: 02 Private

Location: 05 Sidewalk Severity: 03 Moderate Drainage Area: 25

Comments: SMOKE IS COMING FROM ALONG THE SIDE AND IN BACK OF THE HOUSE.

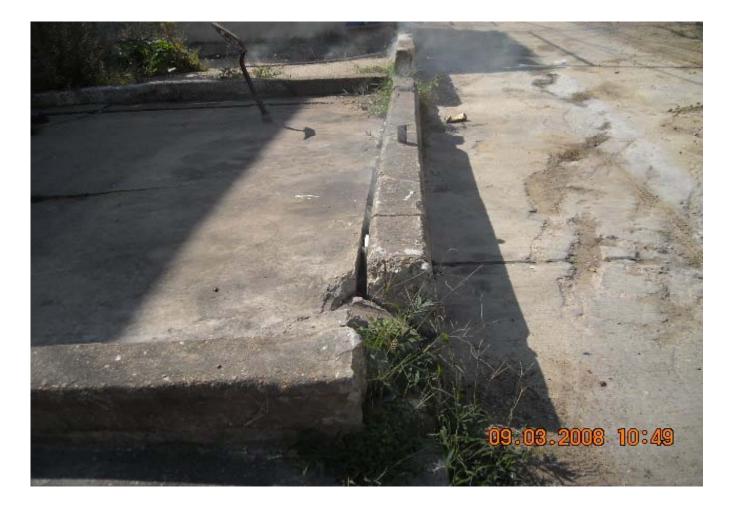
Photograph No: OB02-01 Filename: 1029-592_OB02-01.jpg

Location: 32 S. PULASKI ST.

Source Type: 02 Service Line Sector: 02 Private

Location: 08 Yard - Back Severity: 03 Moderate Drainage Area: 30

Comments: SMOKE IS COMING FROM ALONG THE BACK WALL ADJACENT TO ALLEY.

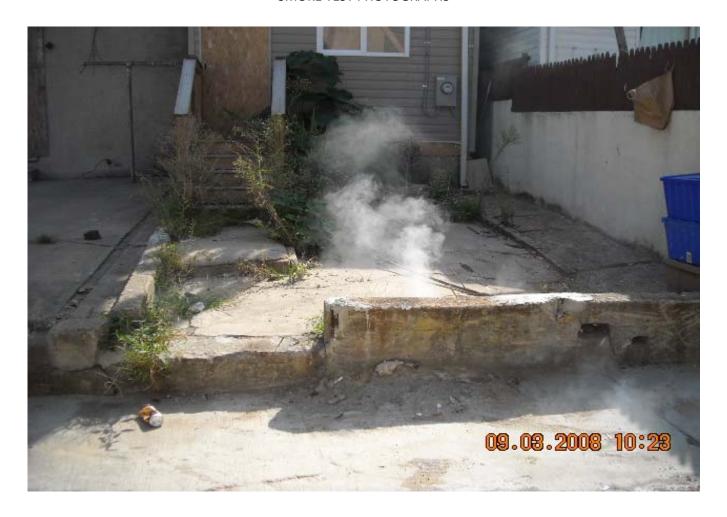
Photograph No: OB03-01 Filename: 1029-592_OB03-01.jpg

Location: 34 S. PULASKI ST.

Source Type: 02 Service Line Sector: 02 Private

Location: 08 Yard - Back Severity: 03 Moderate Drainage Area: 15

Comments: SMOKE IS COMING FROM ALONG THE BACK WALL ADJACENT TO ALLEY.

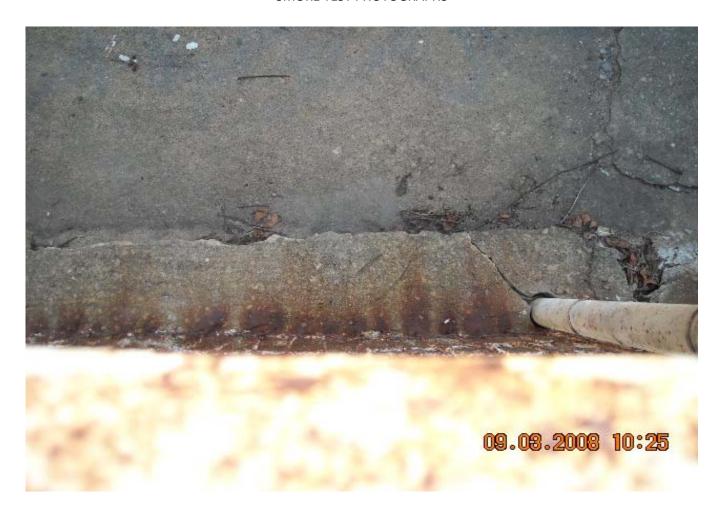
Photograph No: OB04-01 Filename: 1029-592_OB04-01.jpg

Location: 38 S. PULASKI ST.

Source Type: 02 Service Line Sector: 02 Private

Location: 08 Yard - Back Severity: 03 Moderate Drainage Area: 8

Comments: SMOKE IS COMING FROM ALONG THE BACK WALL ADJACENT TO FENCE.

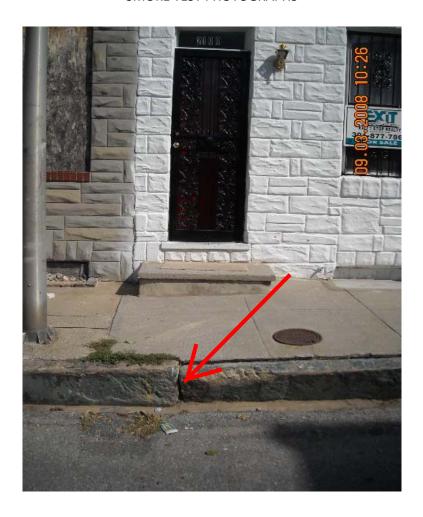
Photograph No: OB05-01 Filename: 1029-592_OB05-01.jpg

Location: 2100 BOYD ST.

Source Type: 02 Service Line Sector: 01 Public

Location: 06 Curb Severity: 03 Moderate Drainage Area: 4

Comments: SMOKE IS COMING FROM CRACK IN MIDDLE OF THE CURB.
